Examples of 270 MHz antenna penetrating reinforcement in slab on grade:

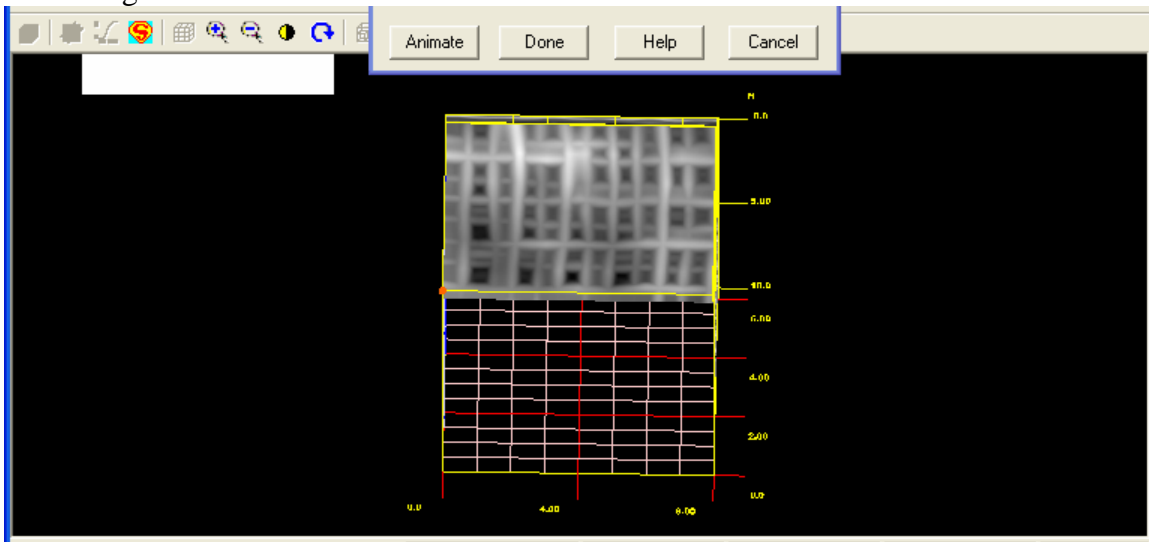
GPR image of slab reinforcement

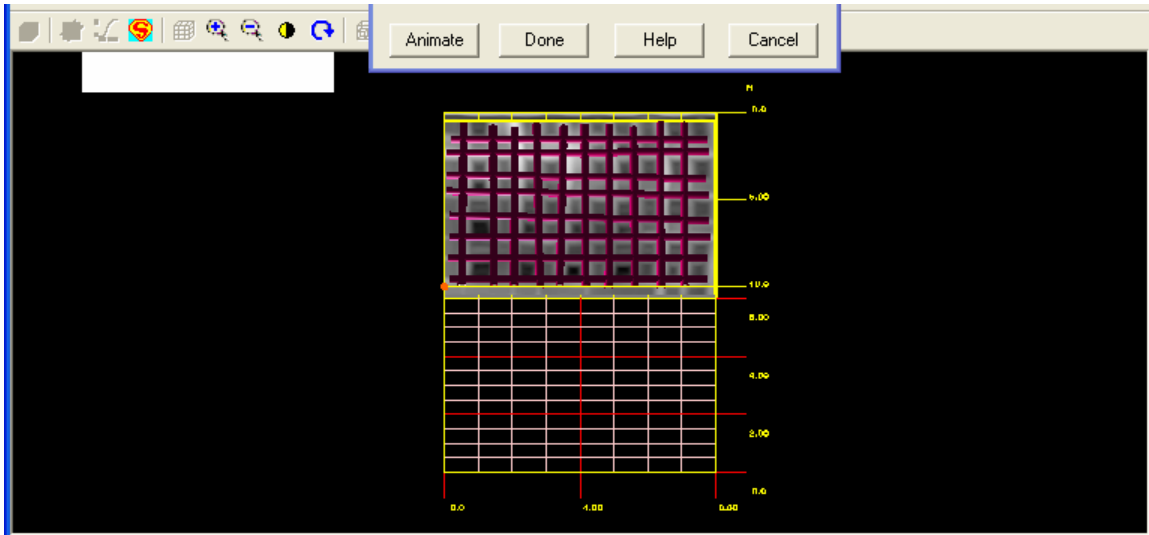
Reinforcement animated

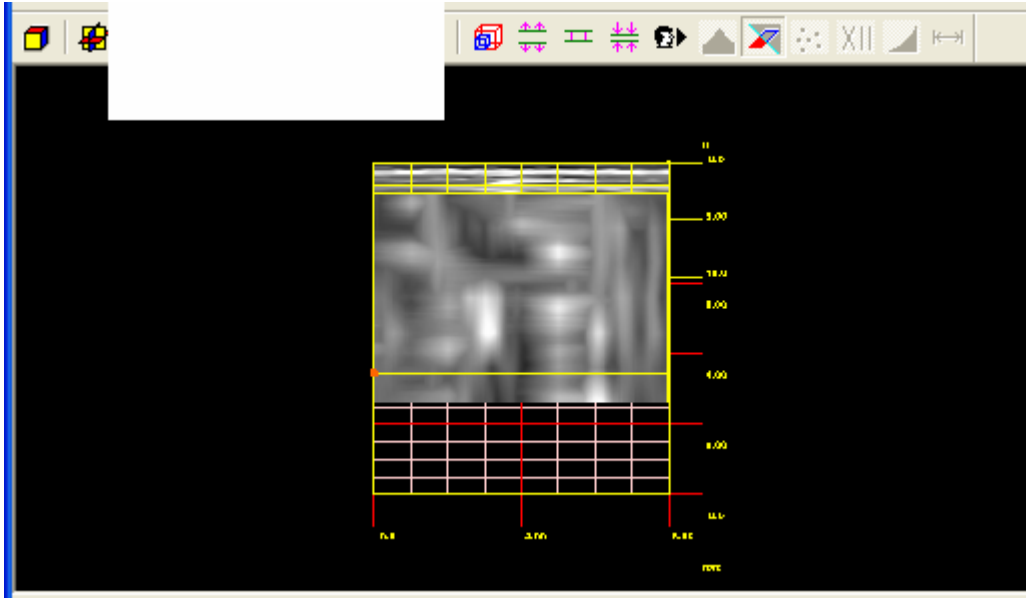
Further into the cube

The image above is difficult to see but to the right of center is a large pipe with three smaller ones to the far right.

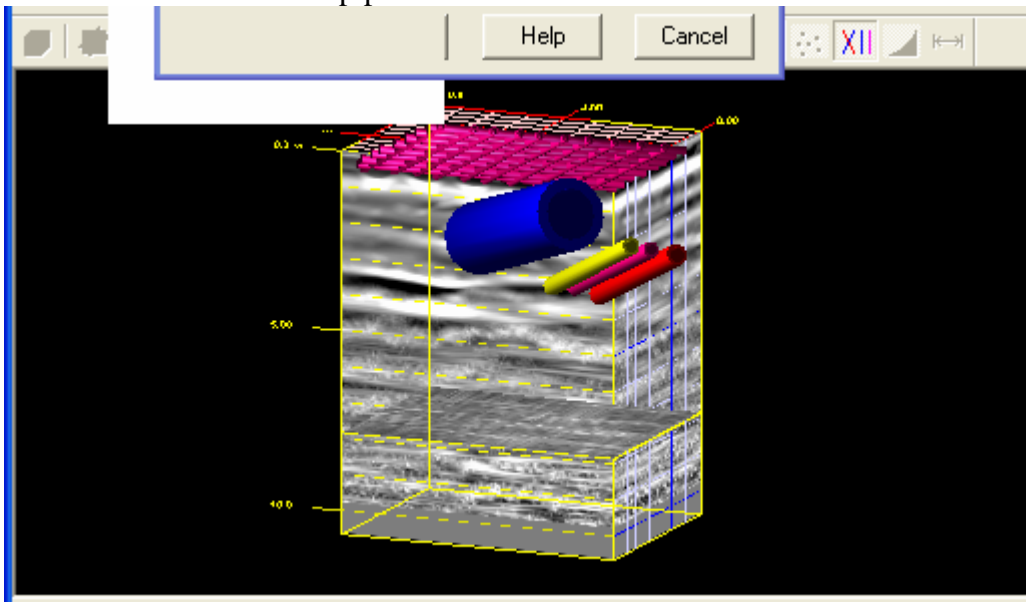
The animated view of the pipes

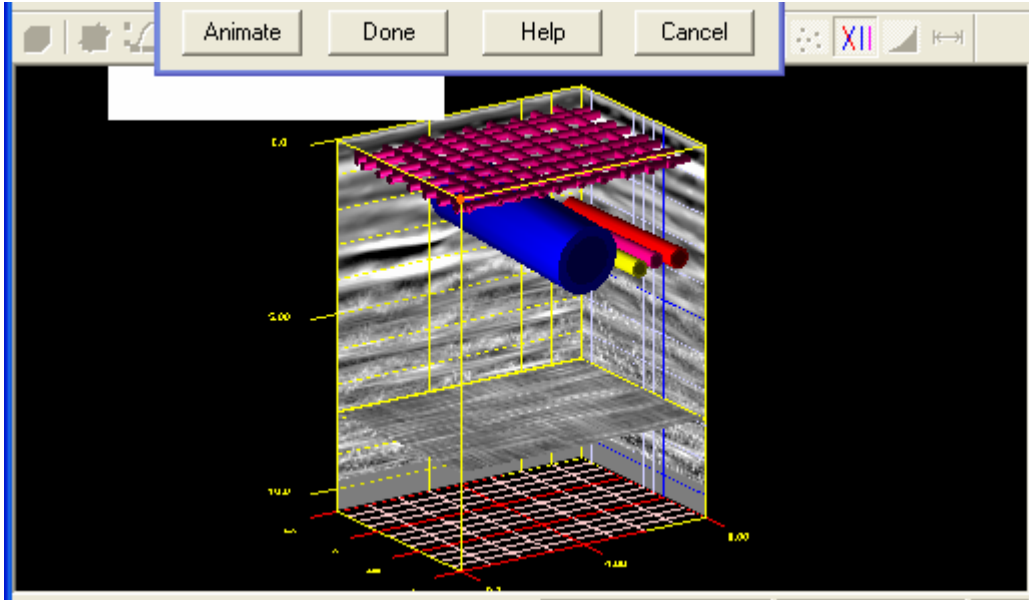
Another view of the same utilities, the larger pipe is a runoff drain and the smaller utilities are electrical and communication lines.

Note the reinforcement on top of the image.
